Manhole Inspection Summary

Manhole # S39KK_001MH

Insp Date: **6/8/09 9:52 AM**

Location Address: **1211 LAFAYETTE ST**

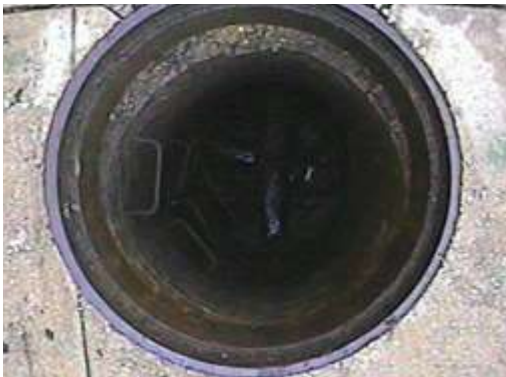
Defect 2

Offset: **3** (in.)

frame offset

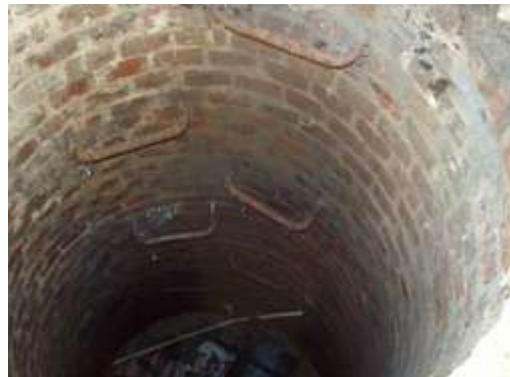
Defect 1

Count: **6** Missing: **0** ☒ **Corroded**

Corroded steps

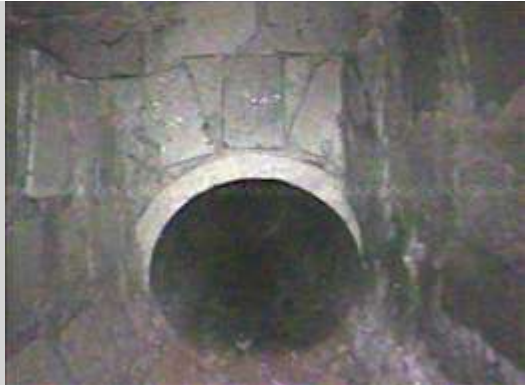
12 O'Clock Outflow

8 in. Circular Gravity Sewer
Pipe Out @ 12 O'Clock

Pipe Material: **Clay** ☐ Pipe Lined

Invert Depth: **7.65** (ft.) Flow Characteristics: **Slow**

Infiltration: **None** Pipe Seal Cond: **Sound**

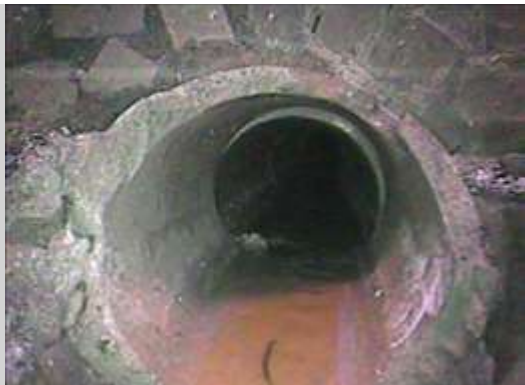
3 O'Clock Inflow

8 in. Circular Gravity Sewer
Pipe In @ 3 O'Clock

Pipe Material: **Clay** ☐ Pipe Lined

Invert Depth: **7.00** (ft.) Flow Characteristics: **Slow**

Infiltration: **None** Pipe Seal Cond: **Broken**

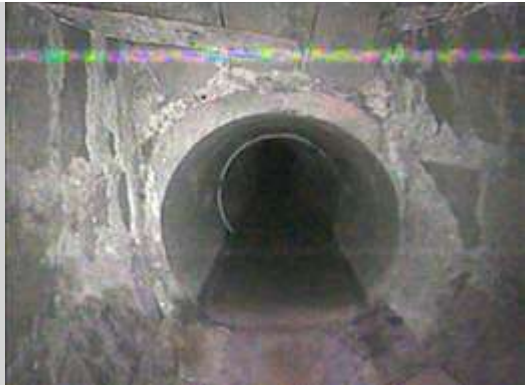
6 O'Clock Inflow

8 in. Circular Gravity Sewer

Pipe In @ 6 O'Clock

Invert Depth: **11.50** (ft.) Flow Characteristics: **Slow**

Infiltration: **None** Pipe Seal Cond: **Sound**

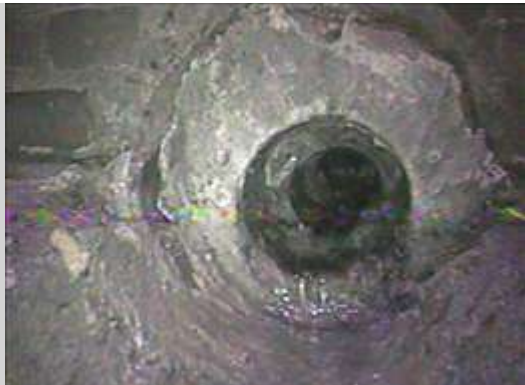
9 O'Clock Inflow

8 in. Circular Gravity Sewer

Pipe In @ 9 O'Clock

Invert Depth: **10.95** (ft.) Flow Characteristics: **Slow**

Deposits: ☐ None ☐ Mud ☒ ~~Sludge~~ ☒ Debris ☒ Grease

Silt Depth: **0** (in.) Deposits Extent: **Light**
